April 14, 2006
Arc Flash Incident
Building 1006A
Brookhaven National Laboratory

Type B Accident Investigation

Judgment of Needs

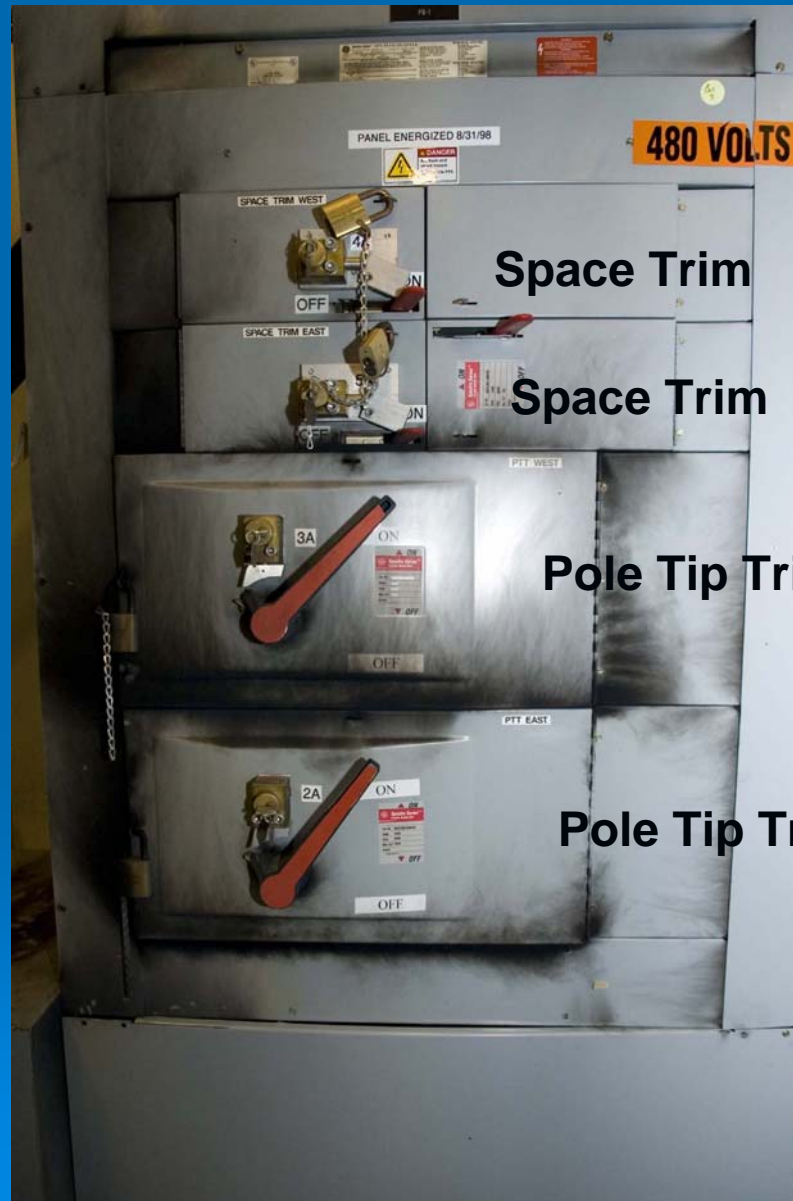
- April 14, 2006 at ~1020
- Building 1006A Mechanical Loft
- Engineer operates 480 V 400 amp disconnect switch
- Arc flash injuries:
 - 1st degree burns to head, face, chest, and hands
 - 1st and 2nd degree burns to forearms
- Switch panel destroyed

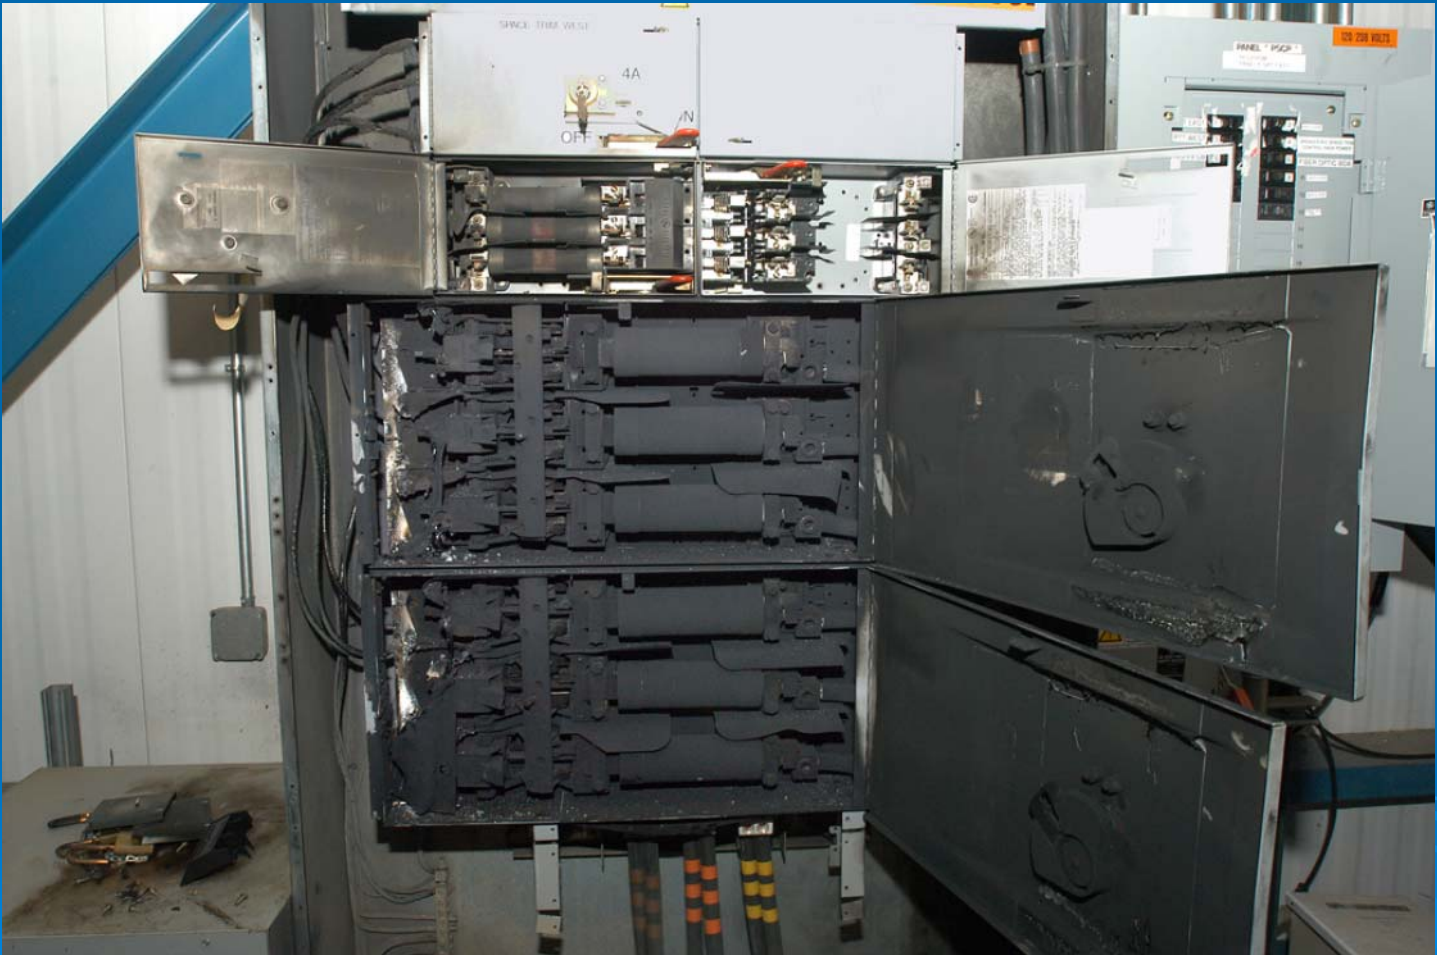
480 Volt STAR Power Supply Circuit Breaker

- The direct cause of the accident was an over voltage on the ungrounded delta power system. An arcing ground fault on a feeder cable, occurring at the resonant frequency of the system, caused the over voltage.
- The possibility of failure of the internal structure of the switch could not be ruled out as a contributing cause.

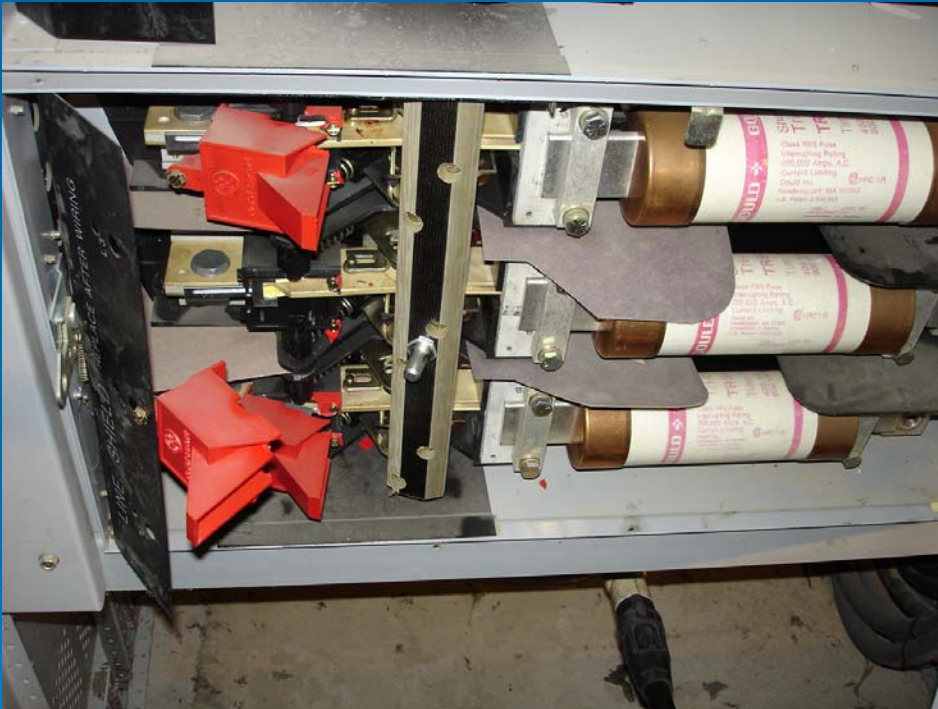
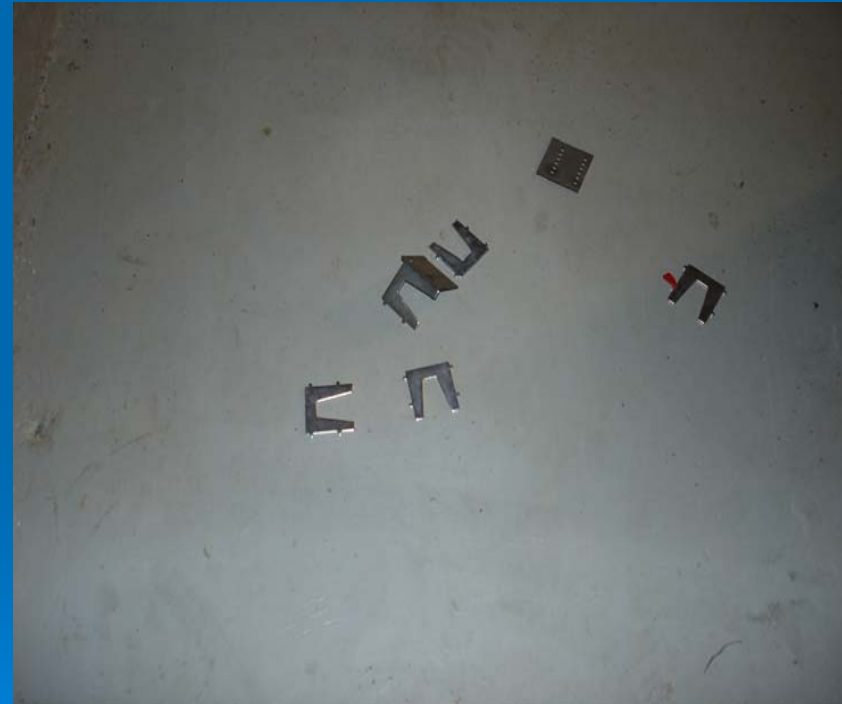
Broken arc chute in Bldg 902 switch

- Inspect GE Spectra Series Switches
